SNAP-8 CORROSION PROGRAM

QUARTERLY PROGRESS REPORT

FOR PERIOD ENDING FEBRUARY 28, 1965

OAK RIDGE NATIONAL LABORATORY
operated by
UNION CARBIDE CORPORATION
for the
U.S. ATOMIC ENERGY COMMISSION

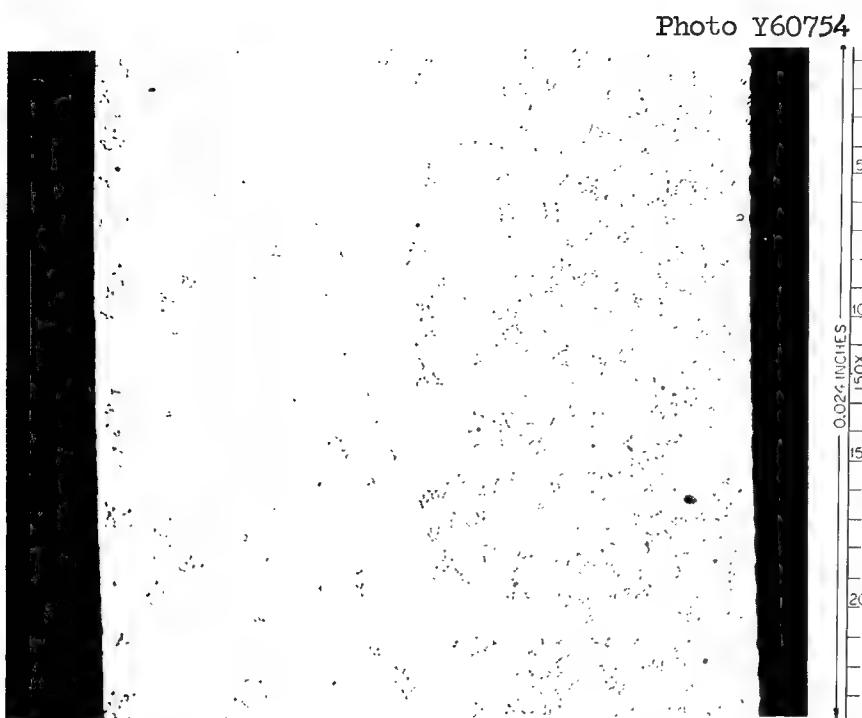
Fig. 3. Carbides (Dark Particles) and Sigma Phase (Light-Gray Particles) in Type 347 Stainless Steel Exposed to NaK at 1400°F for 5133 hr. Specimen No. 5, loop 5-5. Surface exposed to NaK is at right side of photograph.

other portion. Since the specimens were undergoing carburization through the surface exposed to NaK, the apparent separation of phases indicates that carbon enrichment was causing decomposition of sigma-phase material. This is consistent with the general theory regarding the sigma phase in austenitic stainless steels. The carbon acts as an austenite stabilizer. It also removes the chromium from the matrix by formation of chromium carbides, and thus it affects the matrix composition in favor of sigma-phase decomposition.

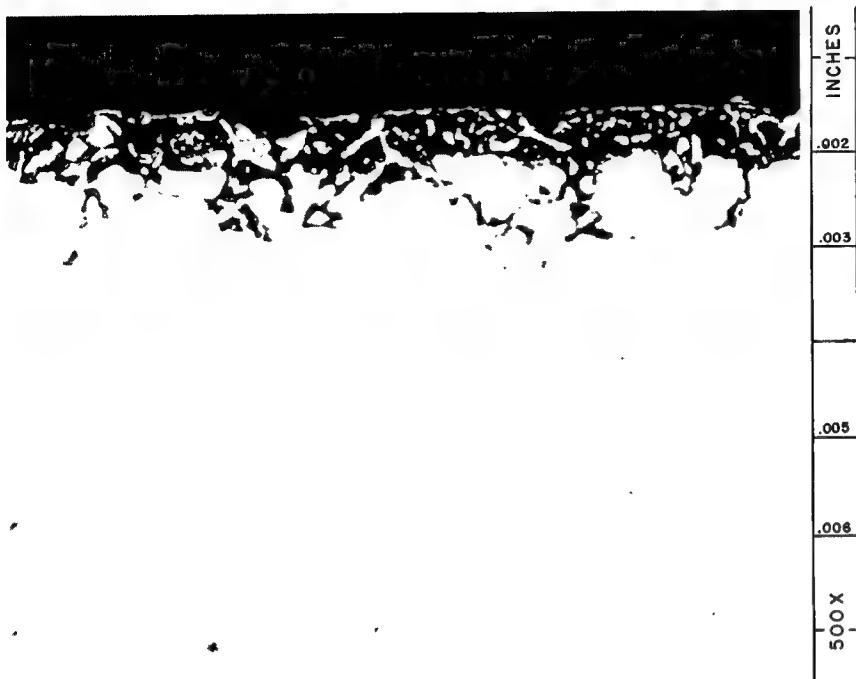
Photo Y60753

Fig. 5. General and Intergranular Corrosion of Hastelloy N Exposed in NaK at 1400°F for 5133 hr. Specimen No. 4, loop 5-5.

to be about 0.5 mil deep, whereas intergranular attack extended about 1 mil beyond the depth of general corrosion. No metallographic evidence of corrosion was found in any of the other materials; however, weight change data showed that the corrosion of type 347 stainless steel at the same temperature was about one-tenth that of Hastelloy N, and type 316 stainless steel located in a lower NaK velocity region was corroded about one-sixth as much as the type 347 stainless steel. The lower NaK velocity is believed to be responsible for the difference in the corrosion rates of these two basically similar materials. Within experimental error, Croloy 9M at 1385°F showed no corrosion. However, considerable carbon migration occurred, as determined by both carbon analysis of insert specimens and metallographic examination. At the hot upstream end of the Croloy 9M piping, the material was decarburized completely across the wall, as depicted in Fig. 6. Two feet downstream at the same temperature, decarburization had proceeded about three-fourths of the way

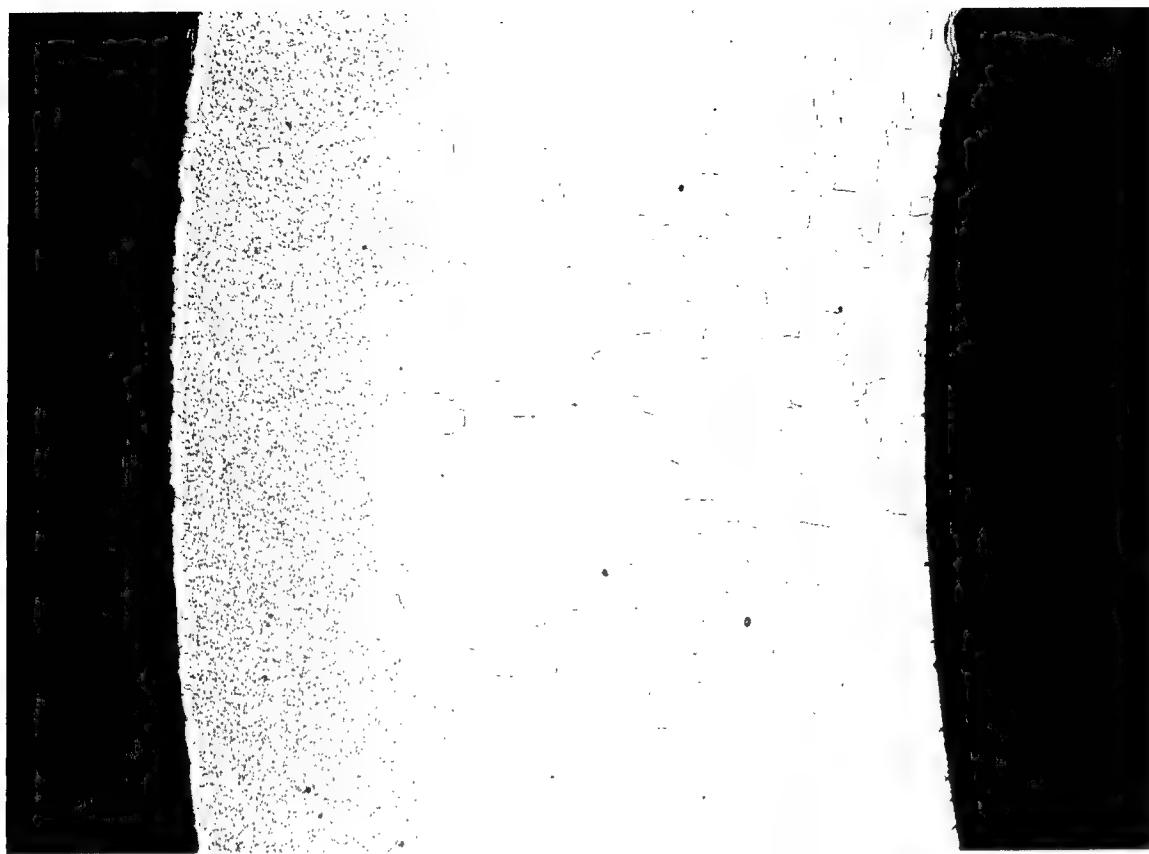
Photo Y60759

across the wall, as shown in Fig. 7. Both figures also reveal the extensive grain growth that accompanied decarburization. The general pattern of carbon migration around the loop was similar to that noted in all previous loops; however, the longer exposure time resulted in a greater degree of carbon migration. The carbon content of type 316 stainless steel at the hot end of the heat exchanger increased from about 0.054% to approximately 0.44%. Metallographic evidence of carburization is shown in Fig. 8. At the cold end of the heat exchanger, Croloy 9M was also carburized as indicated by the pre- and posttest carbon contents of specimens 8 and 9 (see Fig. 9 for specimen location diagram), which increased from about 0.11% to about 0.2%. Metallographic examination did not reveal this, as noted by the relative uniformity of carbides visible

Fig. 7. Decarburized Croloy 9M Piping 2 ft Downstream of that Shown in Fig. 6. Same exposure conditions. 39X

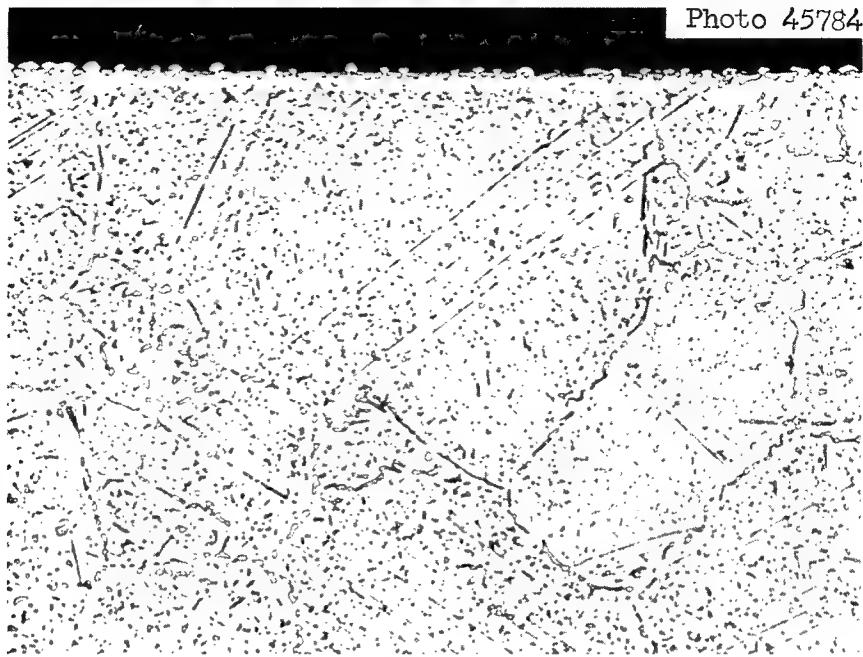
Fig. 8. Carburized Type 316 Stainless Steel Exposed to NaK at 1283°F for 5133 hr. Specimen No. 16, loop 5-5. 500X.

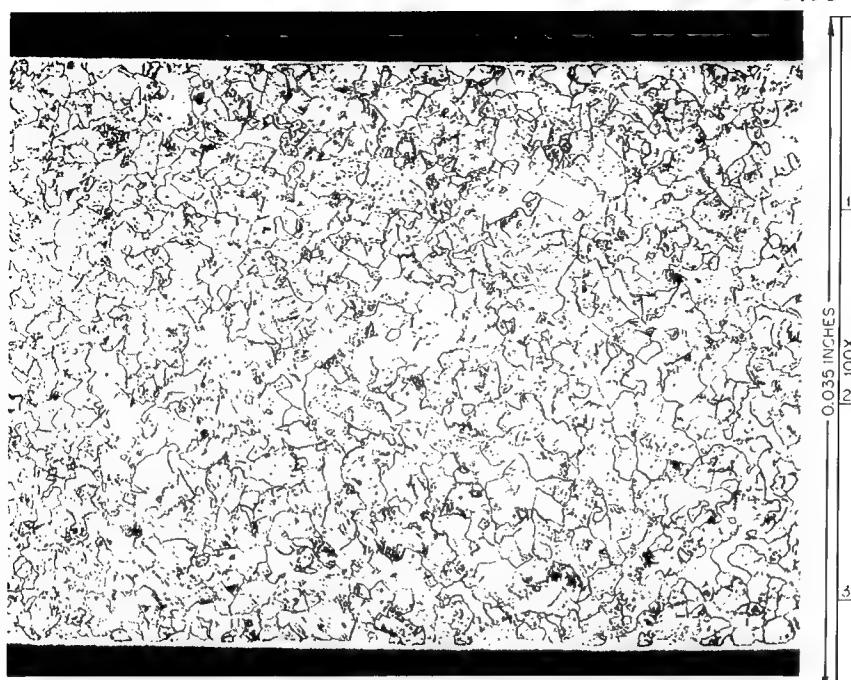
Photo Y60755

in the cross section of specimen 8, shown in Fig. 10. The photomicrographs of Figs. 11 and 12, however, show clearly the difference in the carbide content of specimen No. 9, which was carburized to about 0.2% C, and specimen No. 10, which was decarburized to about 0.03% C. These two pictures also reveal the nickel-rich diffusion layer that resulted from dissimilar metal mass transfer. In the hot-leg portion of the loop, the carbon content of Hastelloy N specimen No. 4 increased from about 0.028 to 0.15%. All carbon contents quoted represent the average for a sample taken across the total thickness of the specimen.

Fig. 10. Carburized Croloy 9M Exposed to NaK at 1110°F for 5133 hr.
Specimen No. 8, loop 5-5.

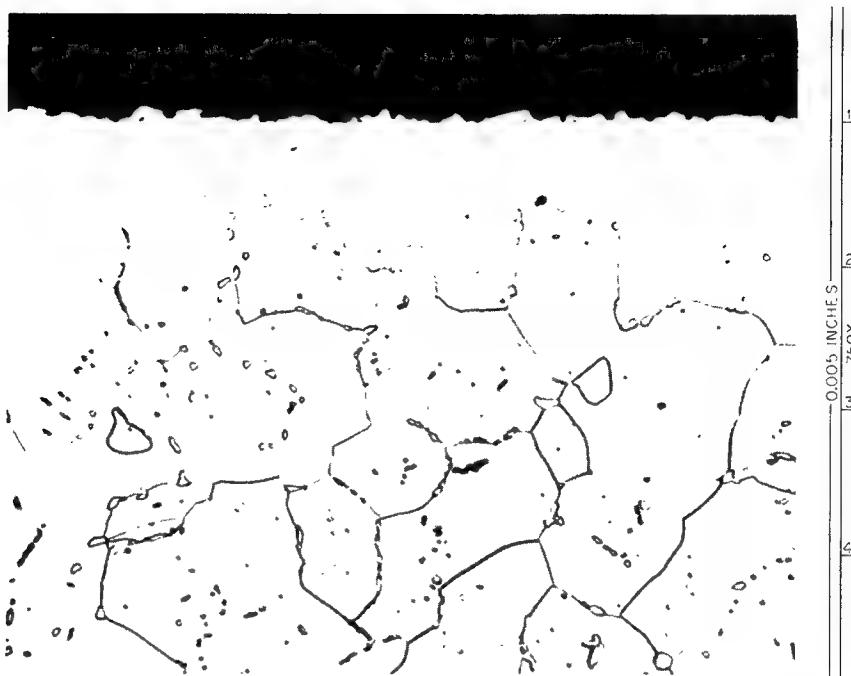
Photo Y60757

Fig. 3.12. Decarburized Croloy 9M Exposed to NaK at 1242°F for 5133 hr. Specimen No. 10, loop 5-5.
